Wetland Evaluation

LTS

3-Point Garden Road East Stroudsburg, Monroe County, Pennsylvania

December 14, 2023

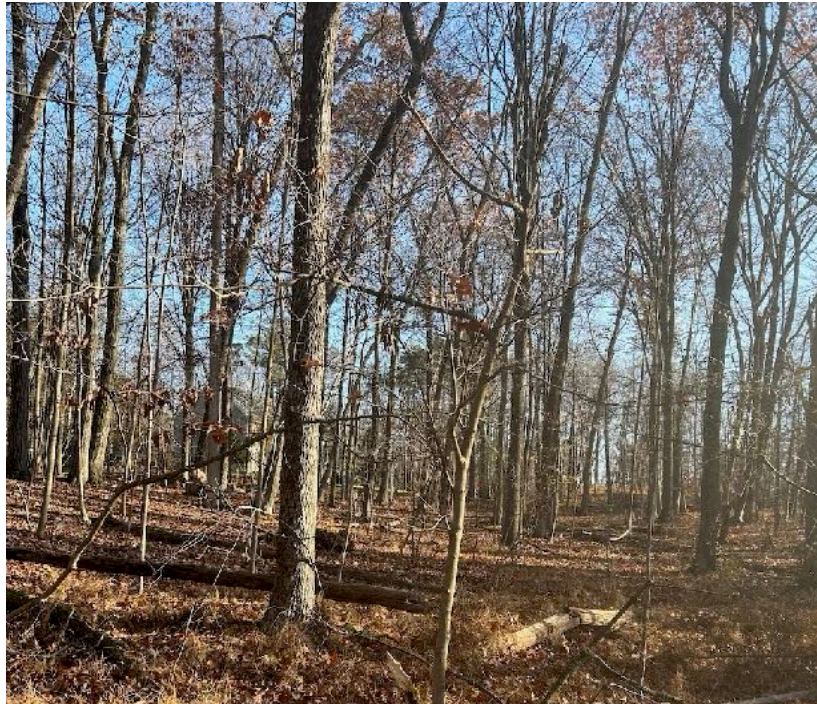
Photo 1. Typical forest view with relatively tall trees and minimal understory (deer!).

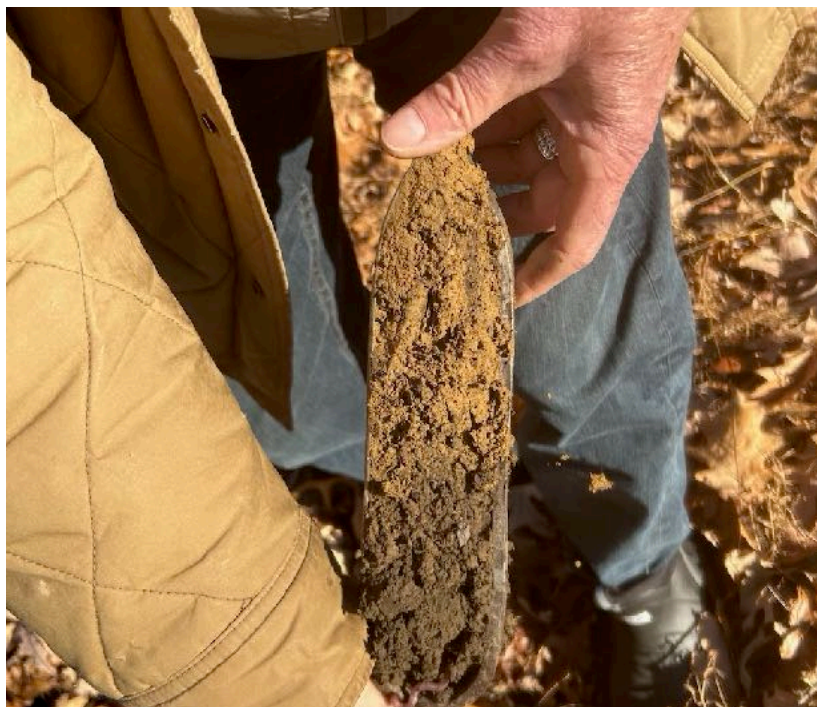
Photo 2. Upland soil; the darker layer the the top layer of soil that is richer in organic matter

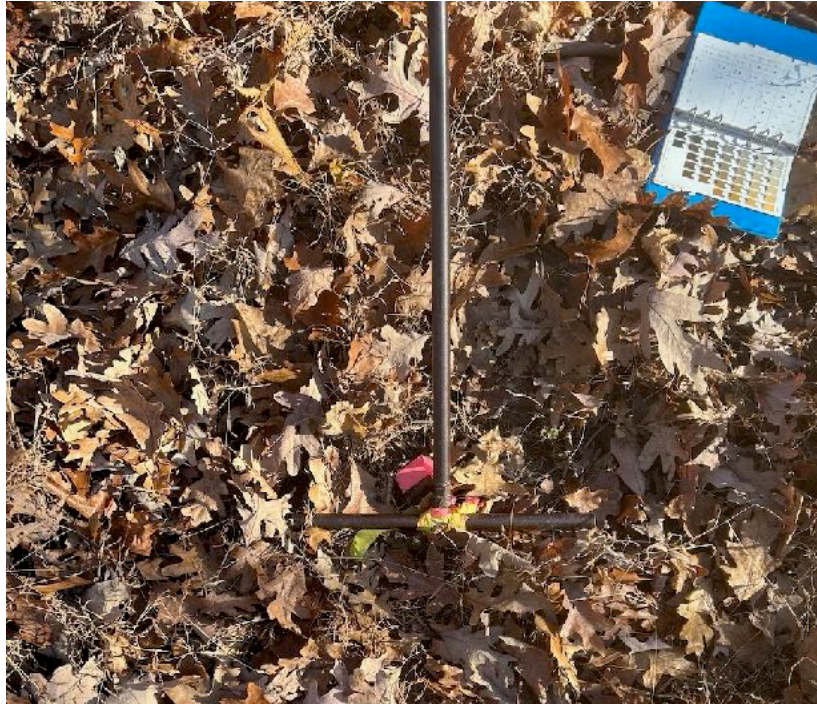
Photo 3. Mostly oak leaves with the Munsell soil color book in the upper right used for on-site characterization of the soil horizons.

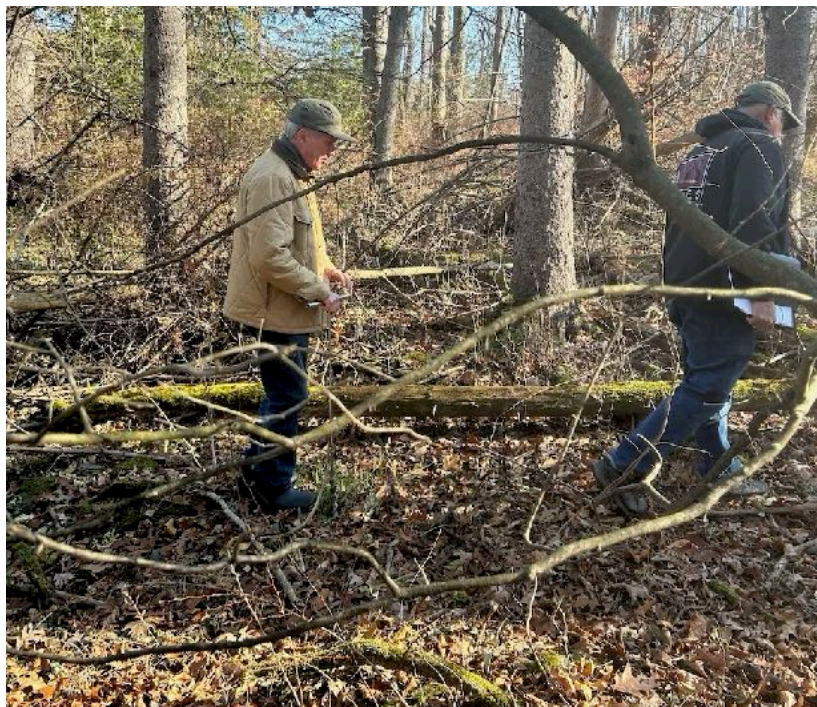
Photo 4. Fallen trees, grape vines, and weedy, non-wetland species.

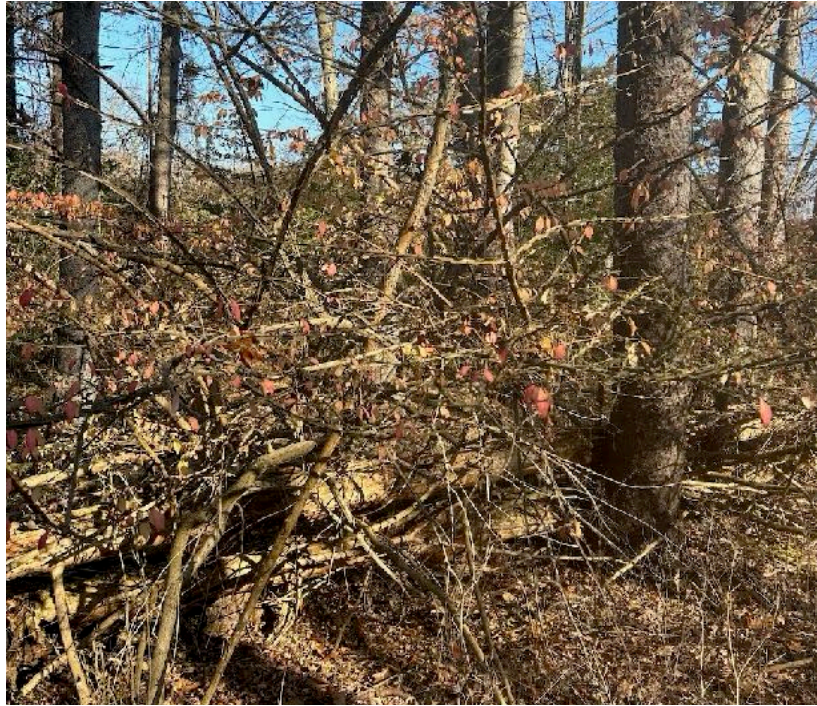
Photo 5. Another dense area with upland shrubs and fallen trees. The fallen trees and brush often limit the deer browse within such areas by blocking their entry and movements.
