Supplemental Stormwater Infiltration Report

Proposed Accessory Buildings Land Development Water Gap Wellness Stroudsburg, Monroe County, Pennsylvania

Date: May 02, 2024
Project No.: 1022419.004

SUPPLEMENTAL
STORMWATER INFILTRATION REPORT
Proposed Accessory Buildings Land Development
Water Gap Wellness
296 Mountain Road
Stroudsburg, Monroe County, Pennsylvania

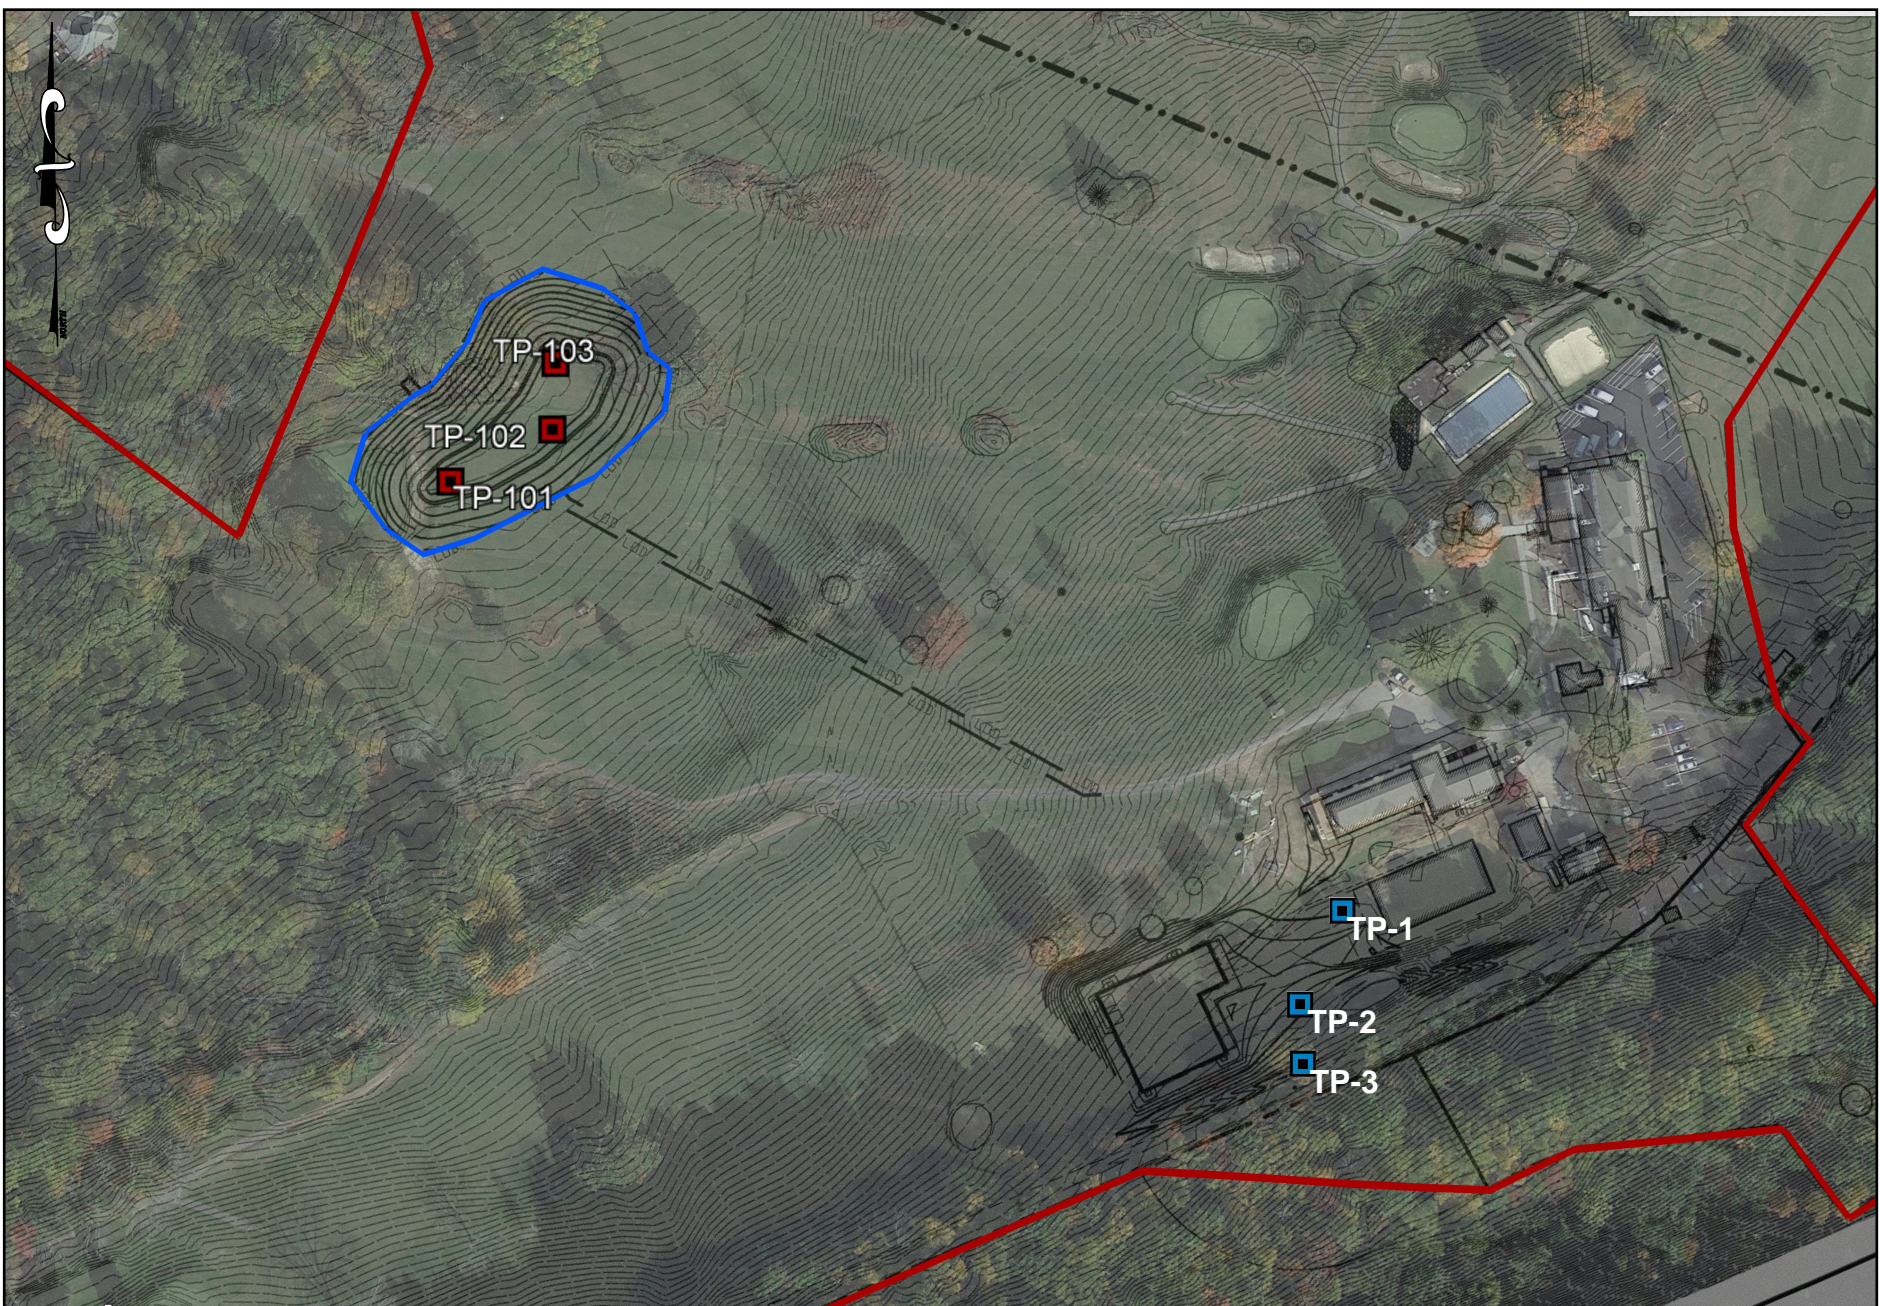
FIGURE 4

On April 26, 2024, three (3) test pits, identified as TP-101 through TP-103, were performed within the footprint of the proposed surface infiltration basin to classify the soil conditions and perform infiltration tests to support the stormwater management design. The test pit locations were determined by the project civil engineer. The excavations were prepared using a Kubota KX040-4 mini-excavator to depths ranging from 5.2 to 5.5 feet below existing grades, corresponding to El. 445.0 ft. to El. 442.6 feet.

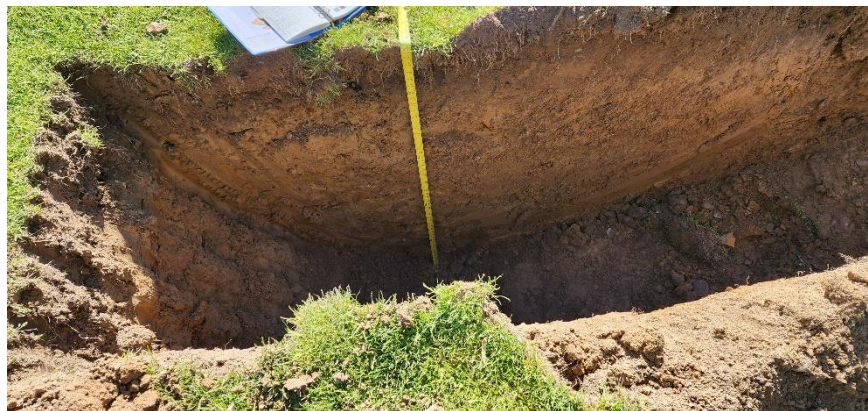
Photo #2 – TP-101 Soil Profile

The soil profile was relatively consistent between the test pits. Below a relatively thin (4 inches) to thick (1.5 feet) layer of surficial topsoil, naturally occurring glacial till soils were encountered. The glacial till soils consisted of Sandy SILT (ML), Sandy Silty CLAY with Gravel (CL-ML), and Silty SAND with Gravel (SM) in accordance with the Unified Soil Classification System (USCS). The glacial till stratum soils were found to be relatively consistent with the description of the Bath channery silt loam.

The glacial soils were gray, tan, dark-brown, and brown, exhibited low plasticity or were non-plastic, were moist to wet, and became increasingly granular with depth. Granular particles were subangular to rounded, indicative of deposition in a glacial outwash environment in the geologic past. Excavation within the glacial till required moderate excavation effort, suggestive of a loose to medium dense relative density.

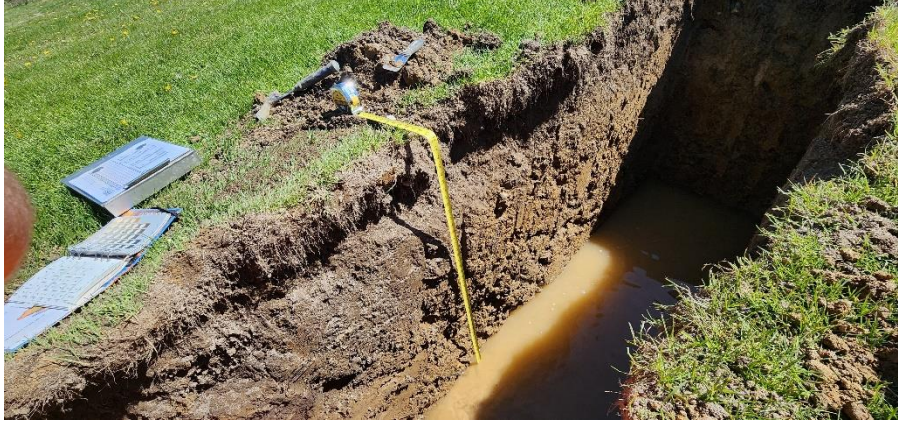
A limiting horizon consisting of a high groundwater table was encountered at the location of TP-102 at approximately El. 446.2 feet. The water surface rose to approximately El. 447.2 feet within one hour of completing the test pit. Groundwater, bedrock, or other limiting zones were not encountered in TP-101 or TP-103 above elevations 444.4 feet and El. 442.6 feet, respectively. The groundwater encountered at TP-102 is representative of an artesian condition originating in the underlying fractured bedrock.

The ability for water to infiltrate the soils was impacted by the relatively high fine-particle (silt and clay) content of the glacial till, as well as the presence of an elevated groundwater table at TP-102.

Photo #3 – TP-102 – Note High Groundwater Limiting Horizon

A limiting condition (high groundwater) was encountered during the exploratory excavation at one location (TP-102). It will be necessary to modify the proposed system where limiting horizons were encountered. It is recommended that the new system be designed with a minimum 2-foot clearance above regularly occurring seasonal high groundwater table to minimize the effect of groundwater mounding on the infiltration system.

In order to maintain compliance with the PA BMP Manual infiltration system guidelines, Isett expects that the invert elevation would have to be raised to a minimum elevation of approximately El. 449.2 feet. Appropriate stormwater management within the study area would involve placement of approved fill to raise grades. The approved fill should consist of an engineered soil mixture of suitable permeability. Additional infiltration testing would be required for acceptance of the engineered soil mixture as an infiltration medium.
