WETLAND REPORT
for
Joe Widmer Property

SMITHFIELD TOWNSHIP
MONROE COUNTY, PENNSYLVANIA

December 15, 2023

Value Engineering Inc

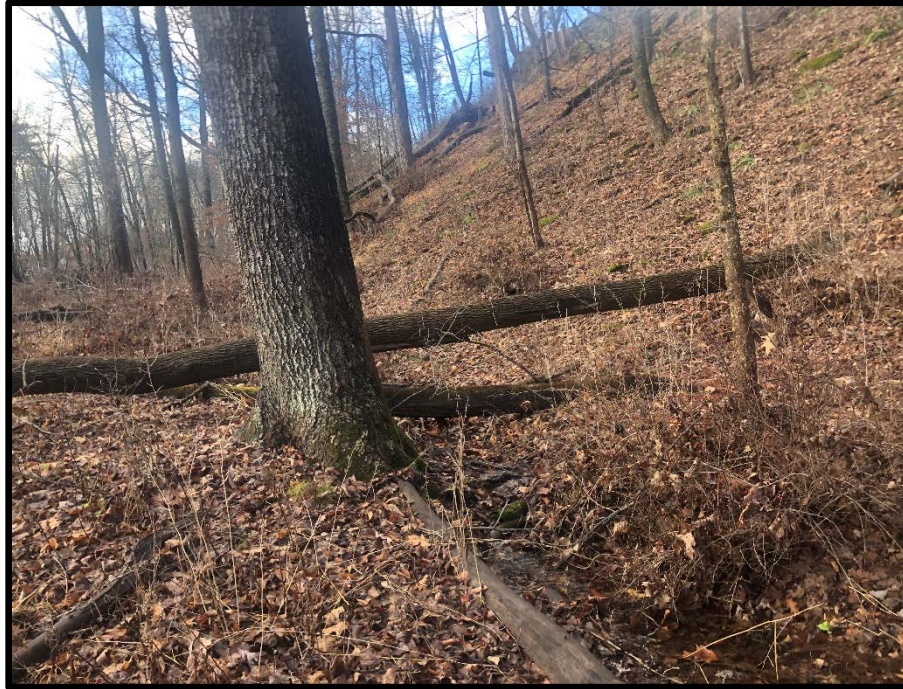
Wooded area along northern property line.

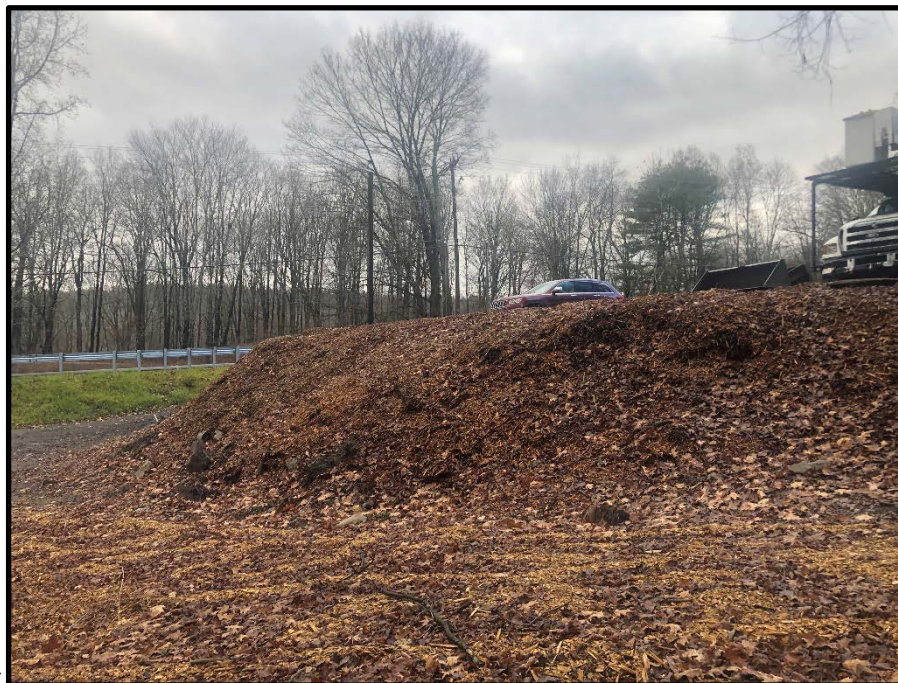
The site has historically been wooded. There is evidence of recent fill soils/wood chip deposition to create a level area to park landscaping vehicles and equipment.

Recent fill/woodchip deposition.
