Wetland Evaluation

LTS

3-Point Garden Road East Stroudsburg, Monroe County, Pennsylvania

Addendum - August 6, 2024

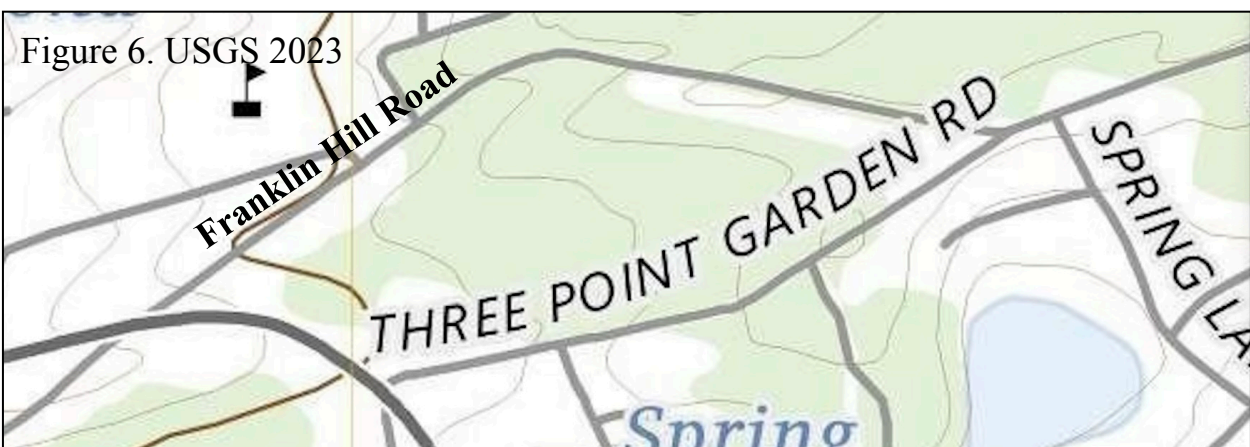
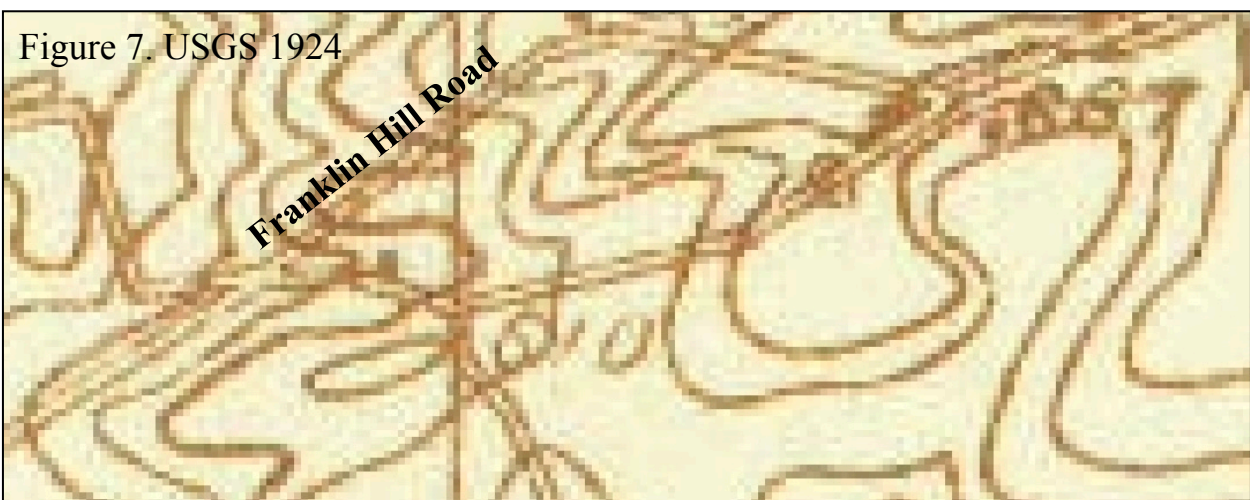
For this addendum we researched the earliest available 7.5-minute Series map which is from 1924 (formally regarded as the Bushkill NJ-PA Quadrangle). The area of interest is shown in Figures 6 and 7 on the following page; representative photos are shown in figure 8 and 9 (page 6)

The area of concern (AOC) is immediately along and parallel to Franklin Hill Road and in neither USGS map is there any notation (stream line) shown. Note that the sloping, ravine-like topography running parallel to the road is clearly recognized without any evidence of a watercourse of any kind in both maps. Elsewhere on the two quadrangles, where streams are present, stream lines are definitely shown as has been the case since the 1800's.

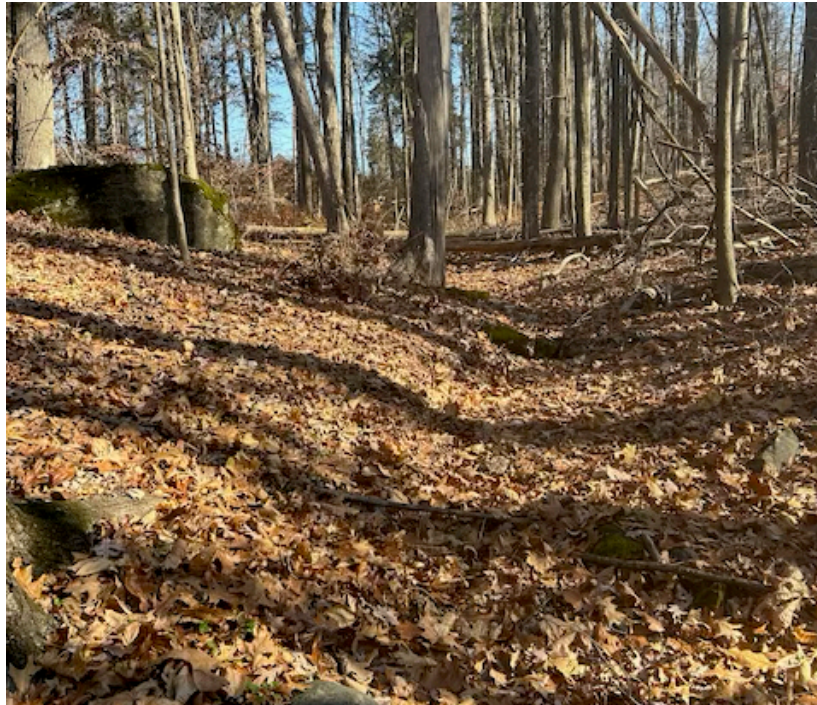
Photo 1. Area of interest along Franklin Hill Road

It is understood that the conservation district posed the question with respect to an anomalous feature along Franklin Hill Road. The geomorphic status of this feature was considered in the initial C&H review. It was and still is evident that the feature is anthropogenic (man made) most likely from the original development of Franklin Hill Road long, long ago; and, after all that time is still not a watercourse, potential stream, and has nothing to do with any natural or other type of historical or regulated watercourse feature. We did not report specifically on the feature in our December 14, 2023, because it did not seem likely to be of any interest at the time.

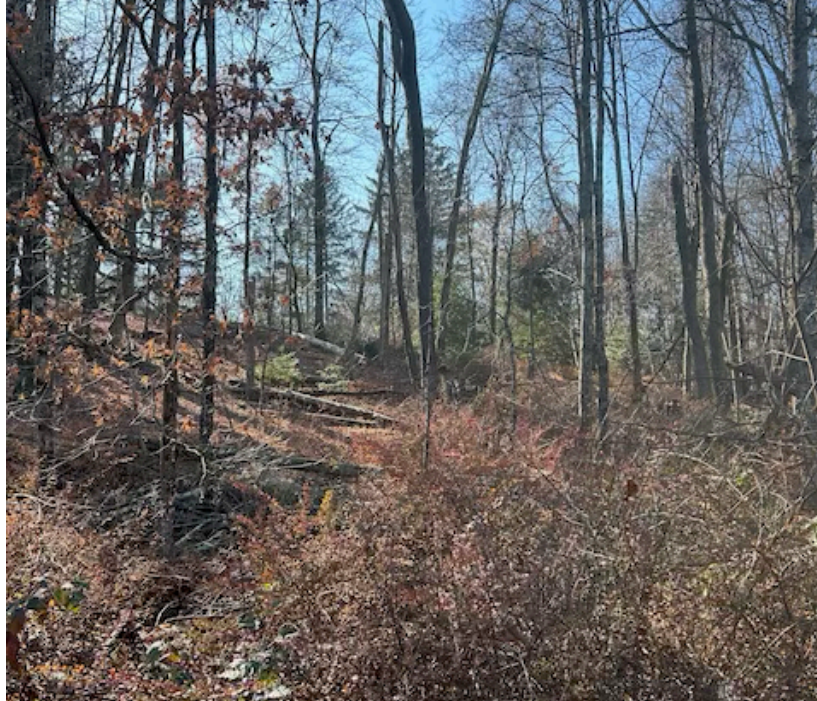
Photo 2. Continuation of the area of interest along Franklin Hill Road.
