Post Construction Stormwater Management Analysis

Water Gap Wellness Accessory Buildings

Smithfield Township
Monroe County, Pennsylvania

Date: August 27, 2024
Last Revised: March 10, 2025
Project #: 1022419.004

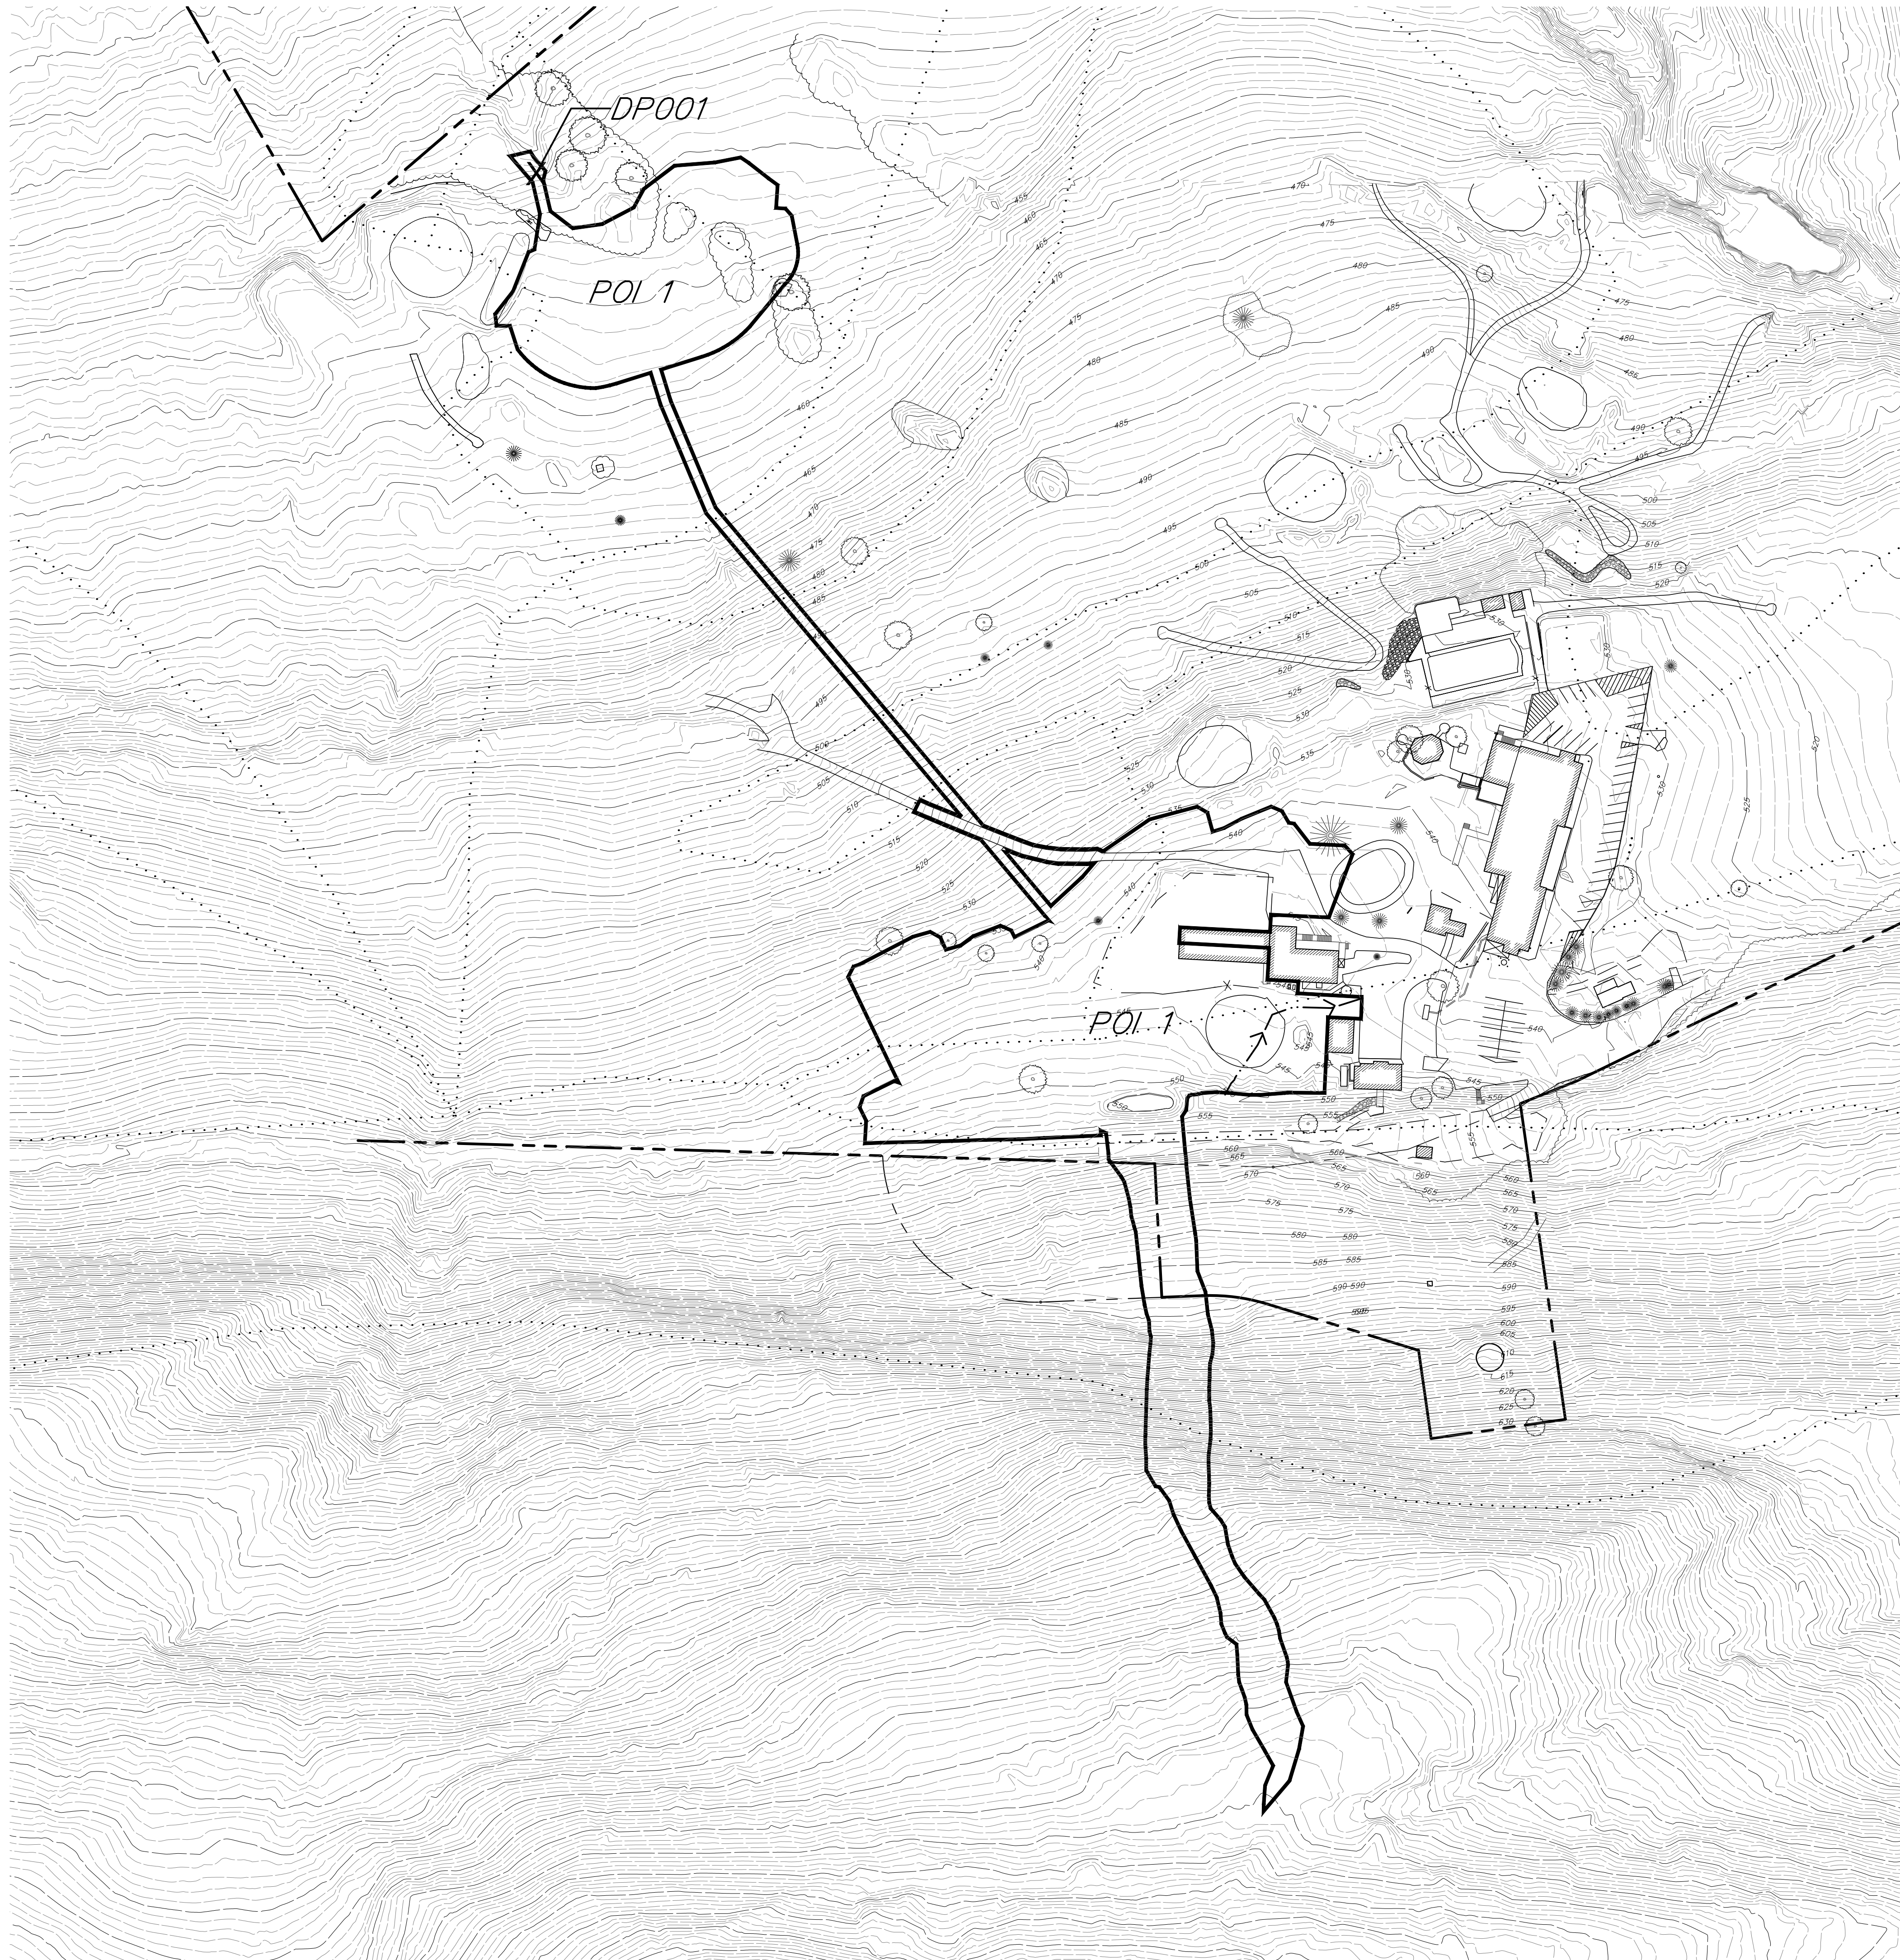
PREVIOUSLY DISTURBED AREAS
PREVIOUSLY DISTURBED AREAS FROM 2022, THAT ARE NOT EXPECTED TO BE REDISTURBED, HAVE BEEN INCLUDED FOR PURPOSES OF STORMWATER ANALYSIS
